# Understanding the Hazard

## Nisqually (Seattle, Wash., USA) Earthquake

*Even moderate earthquake ground-shaking can cause damage to facilities when features intended to resist seismic forces or to accommodate earthquake-induced movement are absent or inadequate.*

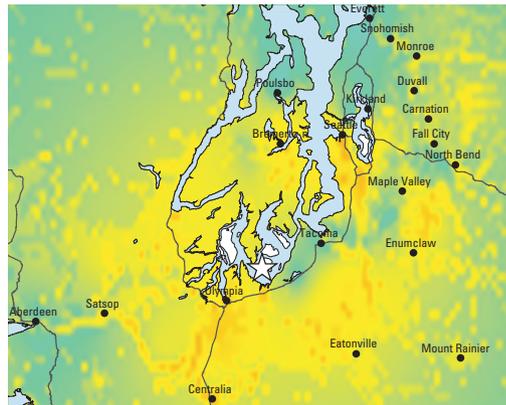
#### Nisqually: Magnitude 6.8

| <b>MMI ≥ VI</b> | 2,800 square miles<br>(7,300 square km) |
| <b>MMI ≥ VII</b> | 200 square miles<br>(520 square km) |
| <b>MMI ≥ VIII</b> | Small pockets |
| <b>MMI ≥ IX</b> | Essentially none |

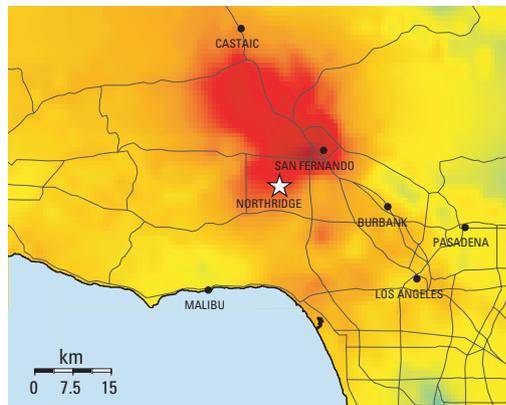
#### Northridge: Magnitude 6.7

| <b>MMI ≥ VI</b> | 2,500 square miles<br>(6,500 square km) |
| <b>MMI ≥ VII</b> | 1,100 square miles<br>(2,800 square km) |
| <b>MMI ≥ VIII</b> | 300 square miles<br>(800 square km) |
| <b>MMI ≥ IX</b> | Small pockets |

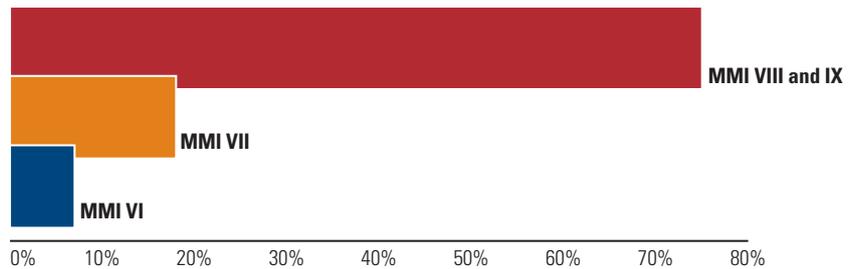
### Percentage of Buildings with Sprinkler Leakage, Northridge, Calif., USA

As illustrated here, the Northridge earthquake demonstrated that sprinkler systems can fail at earthquake intensity levels above MMI VI when not braced as recommended by FM Global.

- **Brace the sprinkler systems:** It is not uncommon for fire sprinkler systems to be inadequately braced in Pacific Northwest facilities. Although the weak ground-shaking resulted in few leaks this time, in stronger ground-shaking, leakage is more likely.
- **Protect against gas fire and explosion:** The Seattle Fire Department responded to gas leaks at 49 locations; six were interior leaks. The potential for gas leaks in a stronger earthquake is significant for many facilities. Installing earthquake-actuated gas shutoff valves, restraining natural gas-fired equipment and providing appropriate flexibility in piping can mitigate this risk.
- **Avoid spills and fire:** In the city of Kent, three chemical spills and one fire resulted from sloshing of contents from open-topped tanks. In more severe or longer duration ground-shaking, the potential for spills would be magnified.
